Performance Evaluation on Low-Crest Breakwater at North Coast of Java Island

Parlindungan Sudrajat Simanjuntak

Board of Kalimantan I River Basin, Ministry of Public Works, Pontianak, INDONESIA

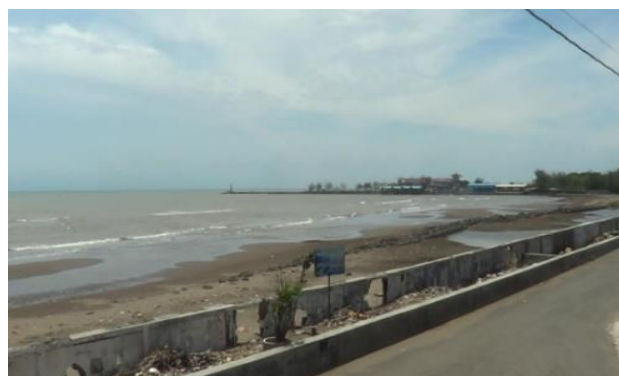
Figure 8. Conditions of Pekalongan Beach in 2017.

Before low-crest breakwater was installed, the beach suffered from erosion and coastal flood that threaten settlement condition around the coast (HuMa, 2006); even though construction of coastal safety has been conducted, such as with seawall, groin, and masonry. After the coastal safety construction used the low-crest breakwater structure, condition of the beach has got several changes, such as beach growth by sedimentation presence in the location where the structure was installed. The view of Pekalongan Beach in 2017 is shown in Figure 8.

Erosion management in Pekalongan City Beach by using low-crest breakwater structure generally showed a positive result, by beach growth of 15 to 20 meters; however, Slamaran Tourism Beach generally has not shown a positive result; it's evident from the yet absence of new beach development in form of beach growth. Further evaluation of this condition should be conducted because other locations on Pekalongan coast already have new beach growth.

This structure was located at 15 to 20 meters distance from the beach, therefore there was no significant damage made by beach visitors. On low-crest breakwater structure with geobag mounted along the beach, repairment and monitoring are necessary, because several damages that occurred, such as sand loss, that could create further destruction. Low-crest breakwater structure with geotube was located on location far from visitors and tourists, but monitoring needs to be conducted on the damages.

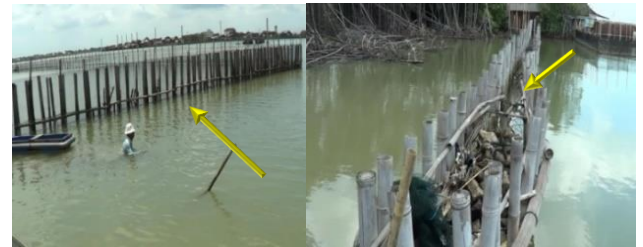
(a) Hybrid Low-crest Breakwater In Front of the Settlement and Mangrove Protection

Hybrid Low-crest Breakwater as shown in Figure 11 was installed on three positions, which are in front of the settlement, at side of the settlement, and at the mangrove plant protection. The observation on Hybrid Low-crest Breakwater showed that the best performance was the ones at the side of the settlement, in which it holds the coastal flood wave that goes

directly to the settlement. There was no material filling on the Hybrid Low-crest Breakwater that was installed in front of the settlement, therefore it is not working; while several points of the installation on the mangrove plant protection were still not filled, therefore the protection does not run well and the mangroves are suffered from damages.

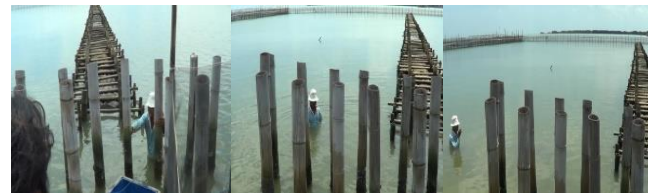
(b) Geobag Low-crest Breakwater with Bamboo Poles

only relatively small damages occurred, in the form of declining position of the bamboo pole, which needs monitoring and repairment. Another repairment that could be conducted is cleaning the shells that are attached, so as not to cause further damage to the structure.
